## CITY OF DAYTONA BEACH RACES AHEAD WITH NEW PRODUCTIVITY TOOL

In June 2008, a 16-inch-diameter cast iron water main ruptured in Daytona Beach, Florida. The main, one of three that service nearby barrier islands and beaches, was 61 years old.

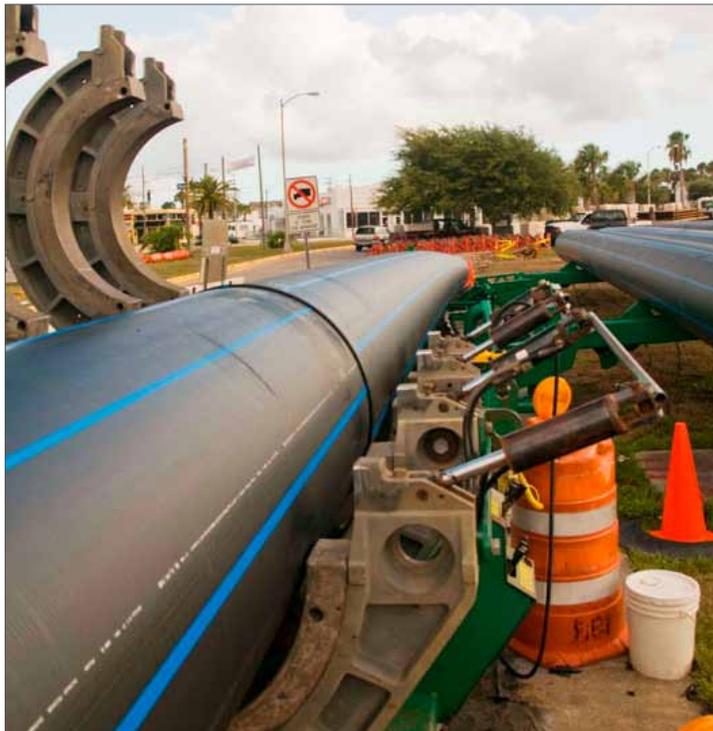
After a fusion joint was cooled, heavy machinery pulled the pipe through to be in position for the next fusion joint.

After a fusion joint was cooled, heavy machinery pulled the pipe through to be in position for the next fusion joint.

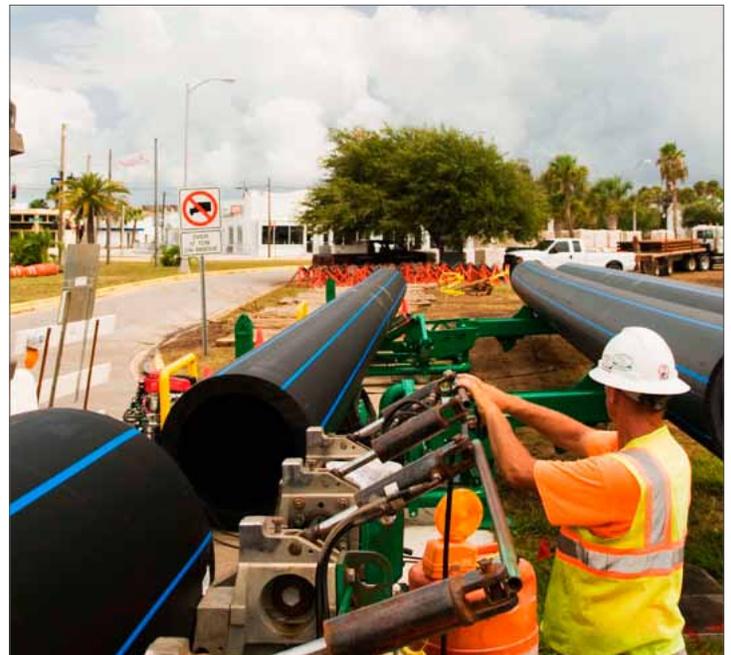
A stick of pipe is dispensed into the powered rollers of the MegaMc PolyHorse. The length of fused pipe has been pulled and is ready for the next 50-foot stick of pipe to be fused onto the length.

A stick of pipe is dispensed into the powered rollers of the MegaMc PolyHorse. The length of fused pipe has been pulled and is ready for the next 50-foot stick of pipe to be fused onto the length.

The McElroy productivity tool allows pipe to be placed on a series of racks directly from a delivery truck. At Daytona Beach, the MegaMc PolyHorse held a shift's worth of fusion work, keeping the pipe stored in a location where it is ready to be used. The MegaMc PolyHorse held 10 50-foot sticks of 30-inch pipe on the rack system that feeds to a dispenser device, and finally, to a pair of powered rollers. One of the rollers features a tracked system that grips and feeds the pipe into the fusion machine, making the fusion process easier on the operator. In tandem, the two powered rollers of the MegaMc PolyHorse help maneuver a stick of pipe up to 24 inches laterally and 34 inches vertically. The device is designed for 20- to 48-inch IPS pipes.

MegaMc PolyHorse. Fusion technicians on site were able to release and load sticks of pipe for fusing with the use of the remote control, which directs all of the functions from the carriage of the fusion machine.
